Chinese-Croatian Joint Colloquium **CONSTRUCTION OF ARCH BRIDGES**

KRK BRIDGE FROM INCEPTION TO TODAY

Zlatko Šavor* Marta Šavor* & Mladen Srbić*

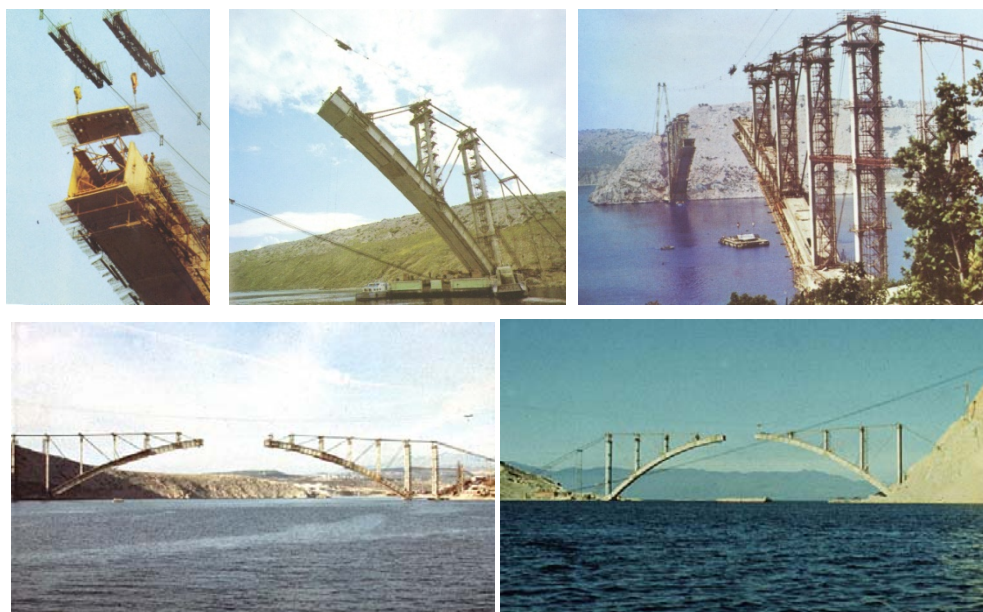
Figure 20: Photos of arch construction

The Krk I arch comprises 40 symmetrically built segments, while the Krk II arch consists of 26 symmetrically built segments. Despite frequent delays and suspensions of works because of rain and strong winds (for example in May 1978 construction site recorded 21 day without works due to poor weather conditions), the central cell of Krk I arch was assembled in only 13 months, while Krk II arch was completed in only 5 months [2].
